**SUSQUEHANNA RIVER BASIN  
SPRING GROVE DAM  
P. H. GLATFELTER COMPANY**

**NDI NO. PA-01028  
DER NO. 67-004**

**YORK COUNTY, PENNSYLVANIA  
PHASE I INSPECTION REPORT  
NATIONAL DAM INSPECTION PROGRAM**

PHASE I REPORT  
NATIONAL DAM INSPECTION PROGRAM

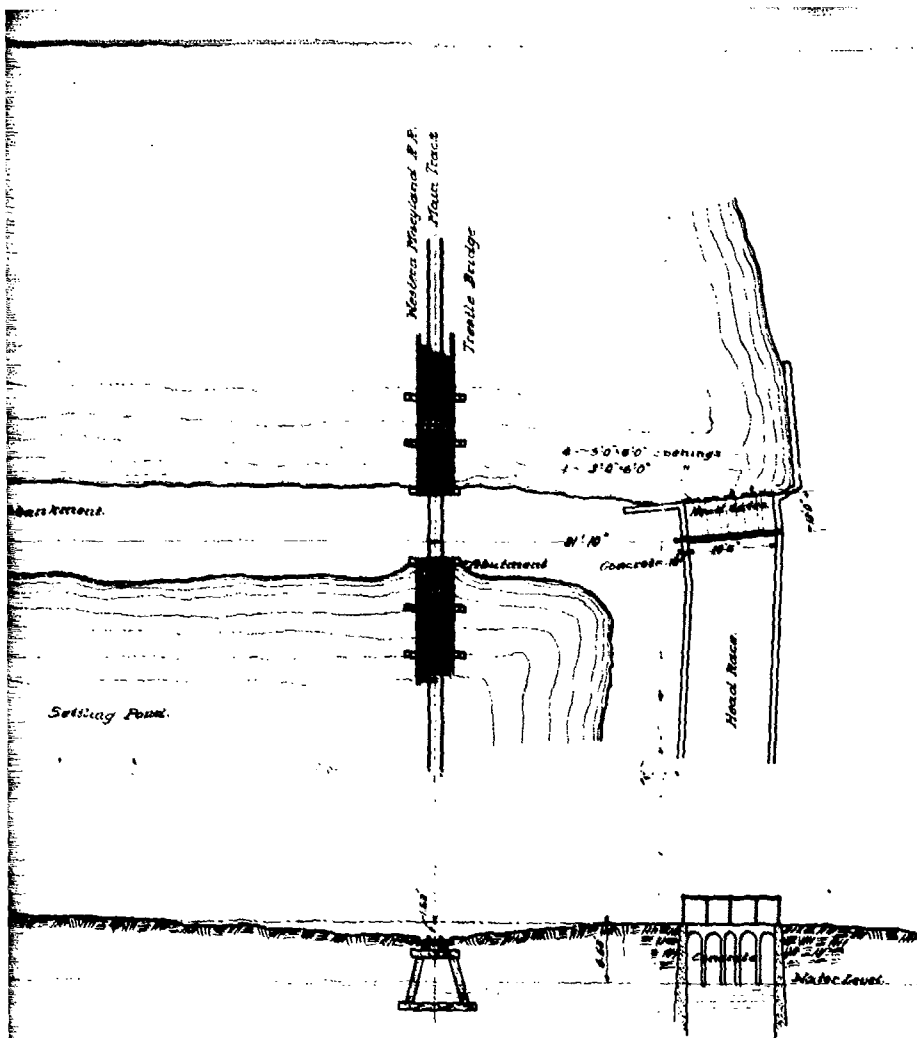
PLATE III   
 PA-01028

A report, prepared by PennDER in February 1914, indicates that the original dam was constructed in 1863. The dam had a 255 foot long, rock ballasted timber spillway which was backed on the upstream side with a clay fill. The heavy masonry abutments were founded on firm material. The crest of the dam was only three feet above the crest elevation of the spillway and overtopping occurred in 1889. When the water receded, the saturated embankment failed and breached. The embankment and the south spillway abutment wall were reconstructed and the crest of the dam was raised to 4.4 feet above the spillway elevation. It was reported that the embankment was founded on firm clay and was constructed of a good clay material. A concrete headrace was constructed in 1889 (Plate III, Appendix E).

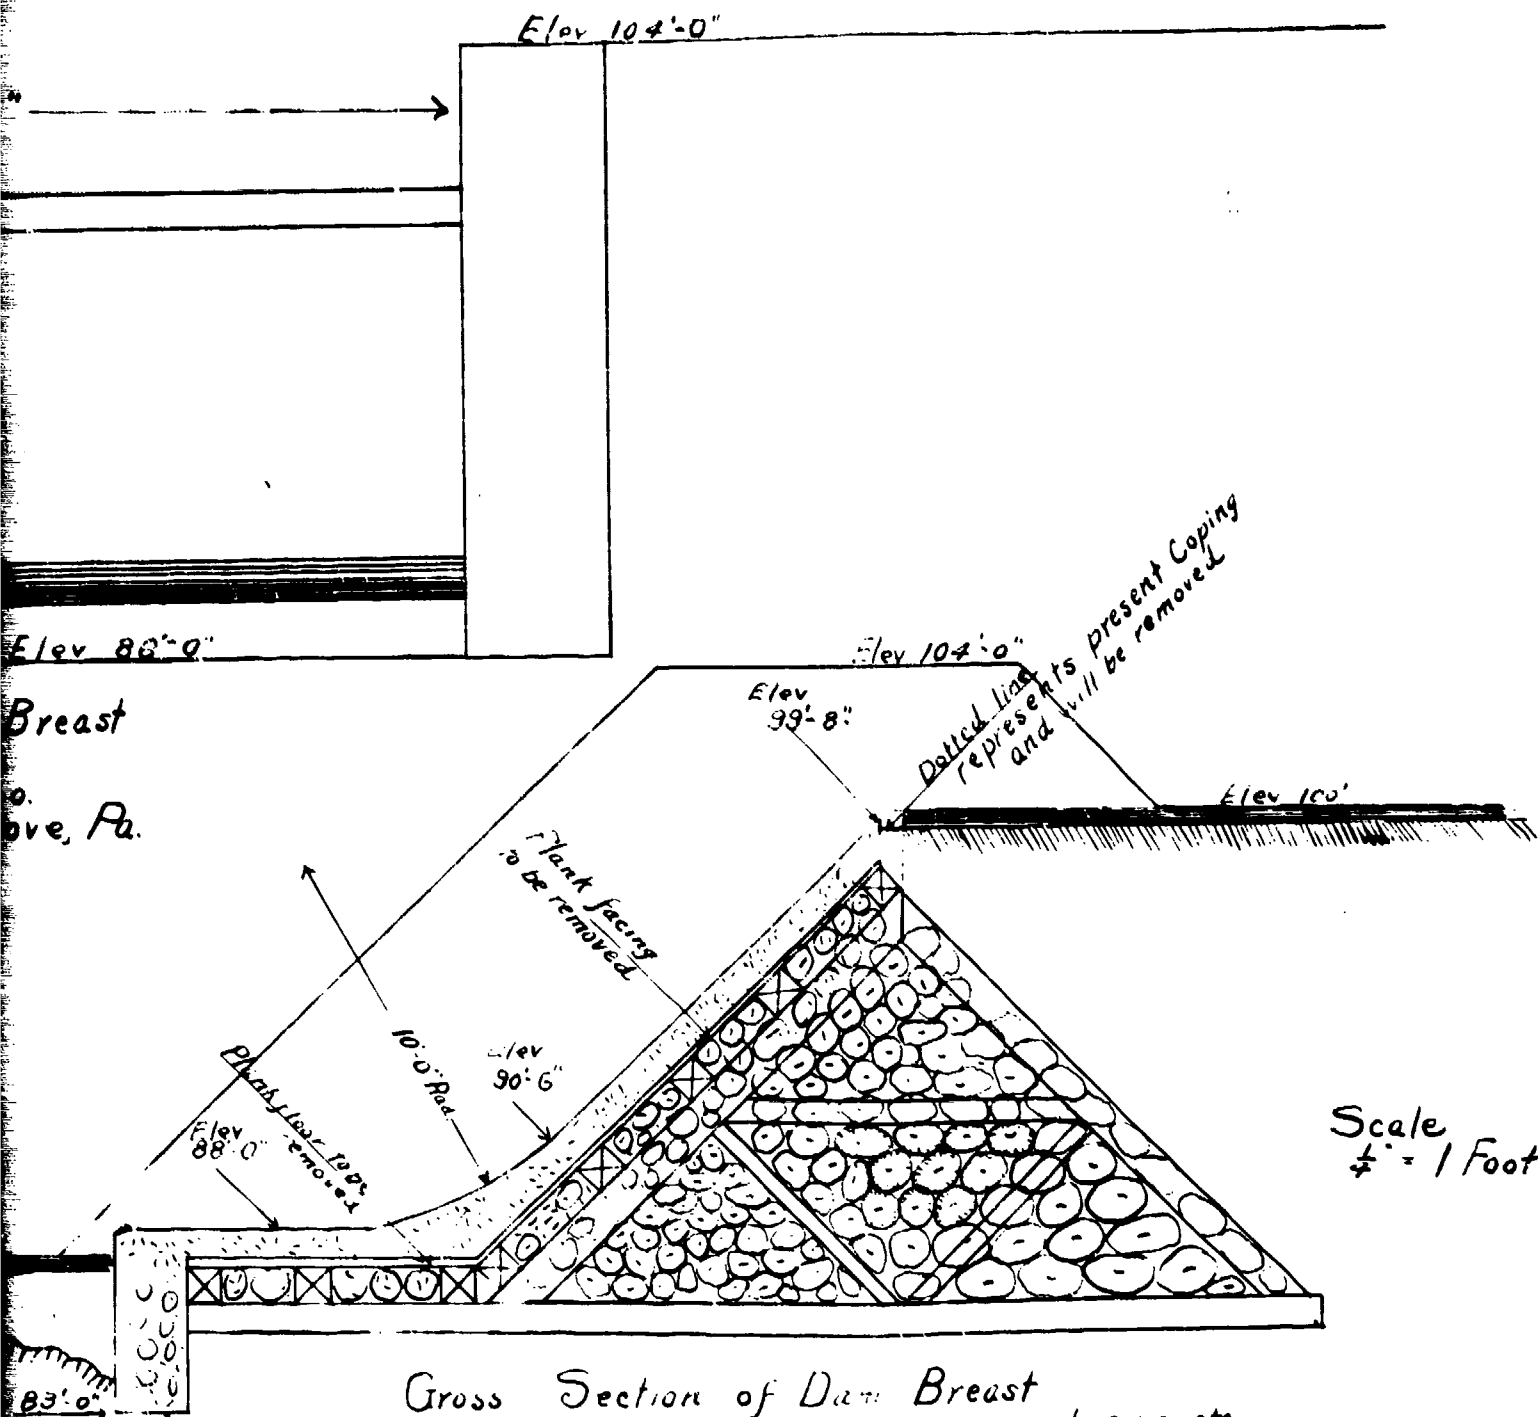
PLATE IV  
PA-01028

In June 1915, concrete was placed on the upstream side of the spillway weir, replacing the planking. It is assumed that this concrete formed a new coping at the top of the weir. In 1924, a permit was issued by PennDER to replace the downstream planking with concrete (Plate IV, Appendix E).
